# ROBT. L. ROWAN, JR., P.E. - ROBT. L. ROWAN & ASSOC., INC. LARRY PHELPS - HESS OIL VIRGIN ISLANDS CORPORATION MARK GERKIN - TENNESSEE GAS PIPELINE COMPANY

#### CASE HISTORY AMERADA HESS GAS PLANT - TIOGA, NORTH DAKOTA

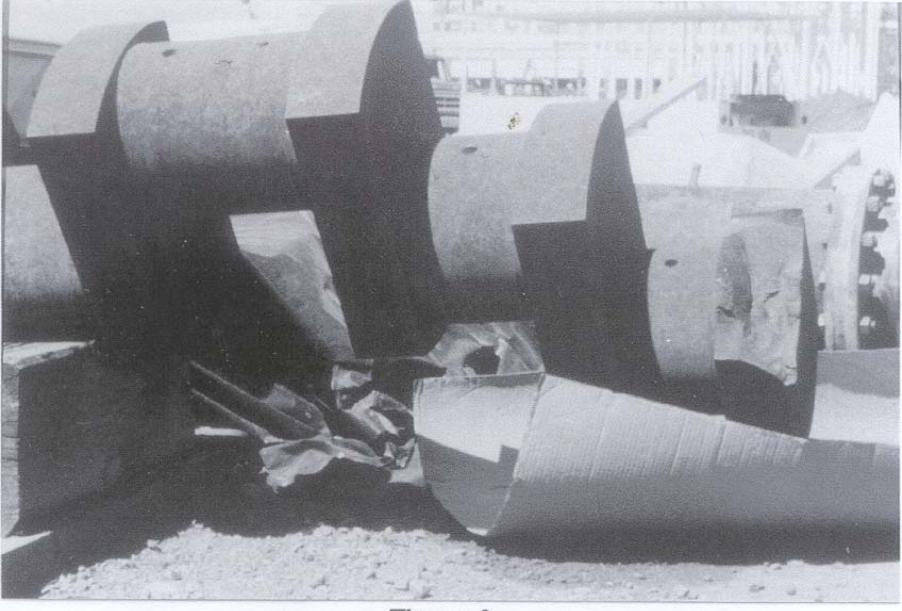
When a crankshaft breaks, there is always a good reason. They don't just break by themselves. In some cases the failure can be attributed to a fault in the crankshaft material, or to an operations induced overload, but in the majority of failures being seen today, improper alignment causes a fatigue type failure. Flexing of the crankwebs, more than manufacturer's tolerances, over time, with enough stress reversals, can and does lead to cracks and breakage. With today's knowledge and technology, this type of crankshaft failure can be controlled more easily than the other two modes of failure mentioned.

Figure 2 Crankshaft failure because of incorrect frame alignment

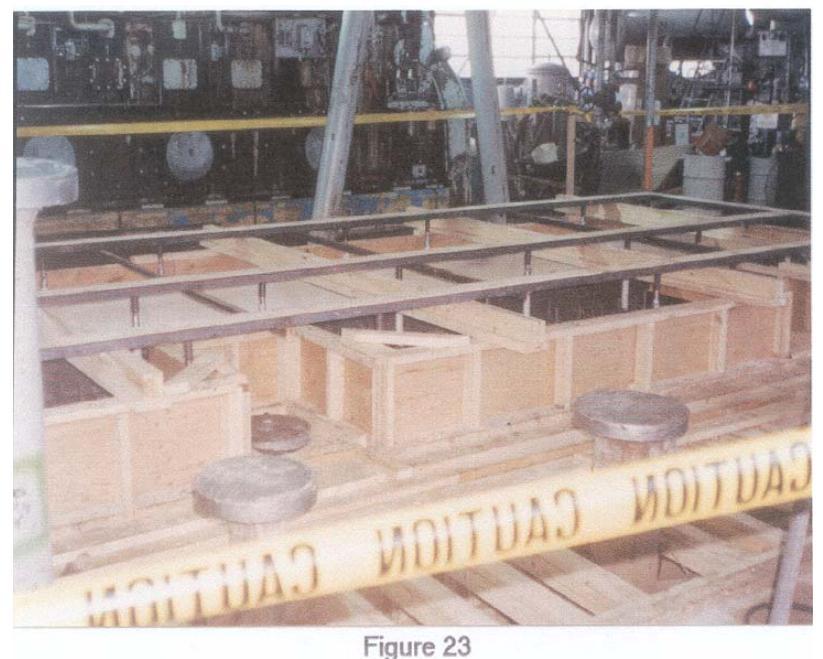
The C1C compressor had cracks in the foundation block, cracks in the grout, and cracks in the epoxy chocks. The compressors were removed from the engine and the complete engine was removed from the foundation by jacking it up and sliding it onto a metal frame built for that purpose. The foundation was found to have oil contaminated cement all the way to basement floor level. The foundation was replaced using the original rebar design and high early cement. The grout used was a high modulus epoxy grout and an adjustable pourable epoxy chocking system was installed.

Foundation prior to re-pouring with polymer modified concrete
