# Robt. L. Rowan & Assoc., Inc.

## Grouting Technology Newsletter

### Grouting Problems

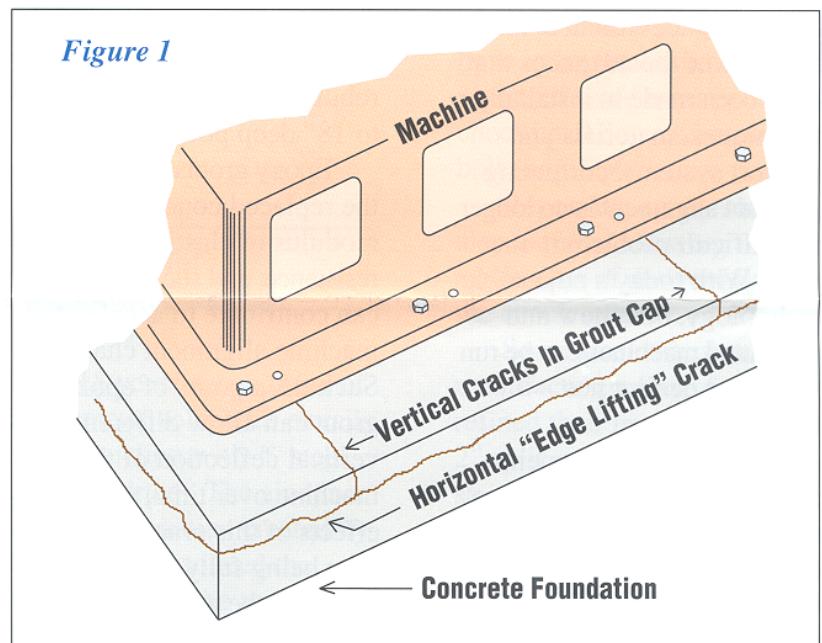
Sometimes what appears to be poor bond of the epoxy grout to the concrete interface occurs on the vertical edge of the concrete block if the grout cap extends to the edge. Particularly with new concrete blocks that have not developed their full tensile strength before grouting, a horizontal crack can develop near the grout interface, usually 1/4” to 1/2” below in the concrete (See Figure 1).

This is the result of a tensile load applied to the concrete by the grout as it cures or thermal movement of the grout cap relative to the grout's higher coefficient of expansion. In this case, the grout is usually bonded to the concrete, but the pull exceeds the tensile strength of the concrete below.

Unless there is a vertical crack in association with the horizontal crack, horizontal cracks, as a rule, start in the concrete and travel upward at a slight angle until they intercept the grout interface and stop. Usually, this will be 2" to 4" from the edge of the block. The limit of this edge failure can be determined by sounding with a hammer.

While the expansion joints used to control vertical cracking also help with the horizontal or edge lifting types of cracks, chipping the edge of the concrete block 30° to the vertical removes the weak shear plane where the cracks start. In addition, the use of rebar wickets or dowels on 6" to 10" centers along the edge gives extra holding to resist the forces that can cause a horizontal crack, particularly on large corner shoulders (See Figure 2). A diagonal expansion joint across the corner, which will divide the grout mass, thus reducing the magnitude of the forces, is another effective way of controlling this problem.
